REPORT  
ON THE WRECK OF THE  
SS RICHARD MONTGOMERY

Maritime and Coastguard Agency  
Spring Place  
105 Commercial Road  
Southampton  
SO15 1EG

November 2000

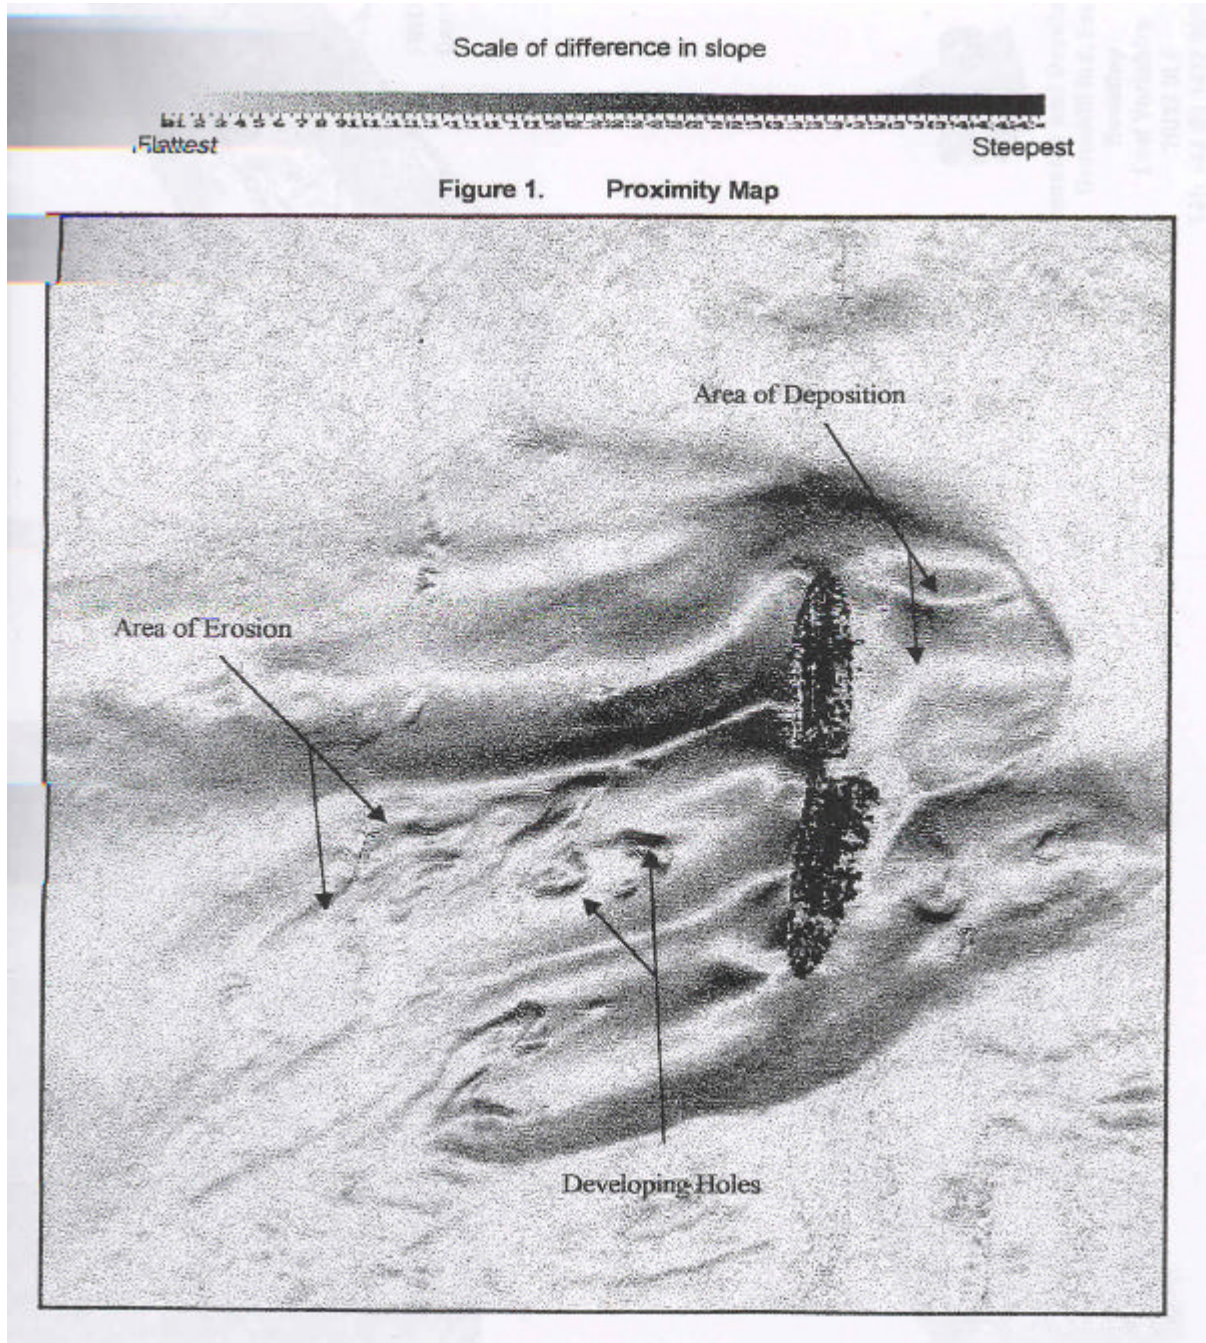
MONOCHROMATIC GRADIENT PLOT 2000

16. The monochromatic gradient plots in Appendix 4 reveal details of the ship's structure. These plots also reveal details of small seabed topographical features such as sand ripples over the area.

20. The orientation and position of the wreck were observed. The following points were noted:
  - The crack observed in the starboard side of the forward section in last year's survey was not detected in the 2000 survey.
  - A hole has been observed in the port side of the forward section. The dimensions of the hole are approximately 1 m wide x 2.5 metres high. It is approximately 1.5 metres below deck level. This suggests significant deterioration of the hull plates.
  - Eight items of overhanging debris have again been detected. These have been provisionally identified as derricks from forward and aft masts, and 4 life-boat davits.
  - The debris between the two pieces of wreck is generally unchanged from the previous survey.

21. The inspection of the wreck shows that there has been some changes to the structure below surface. In last year's survey, an object was observed to have fallen from the superstructure onto the seabed, and 2 large holes have been observed on the seabed to the west of the aft section of the wreck. This year a hole has appeared in the side of the port bow.

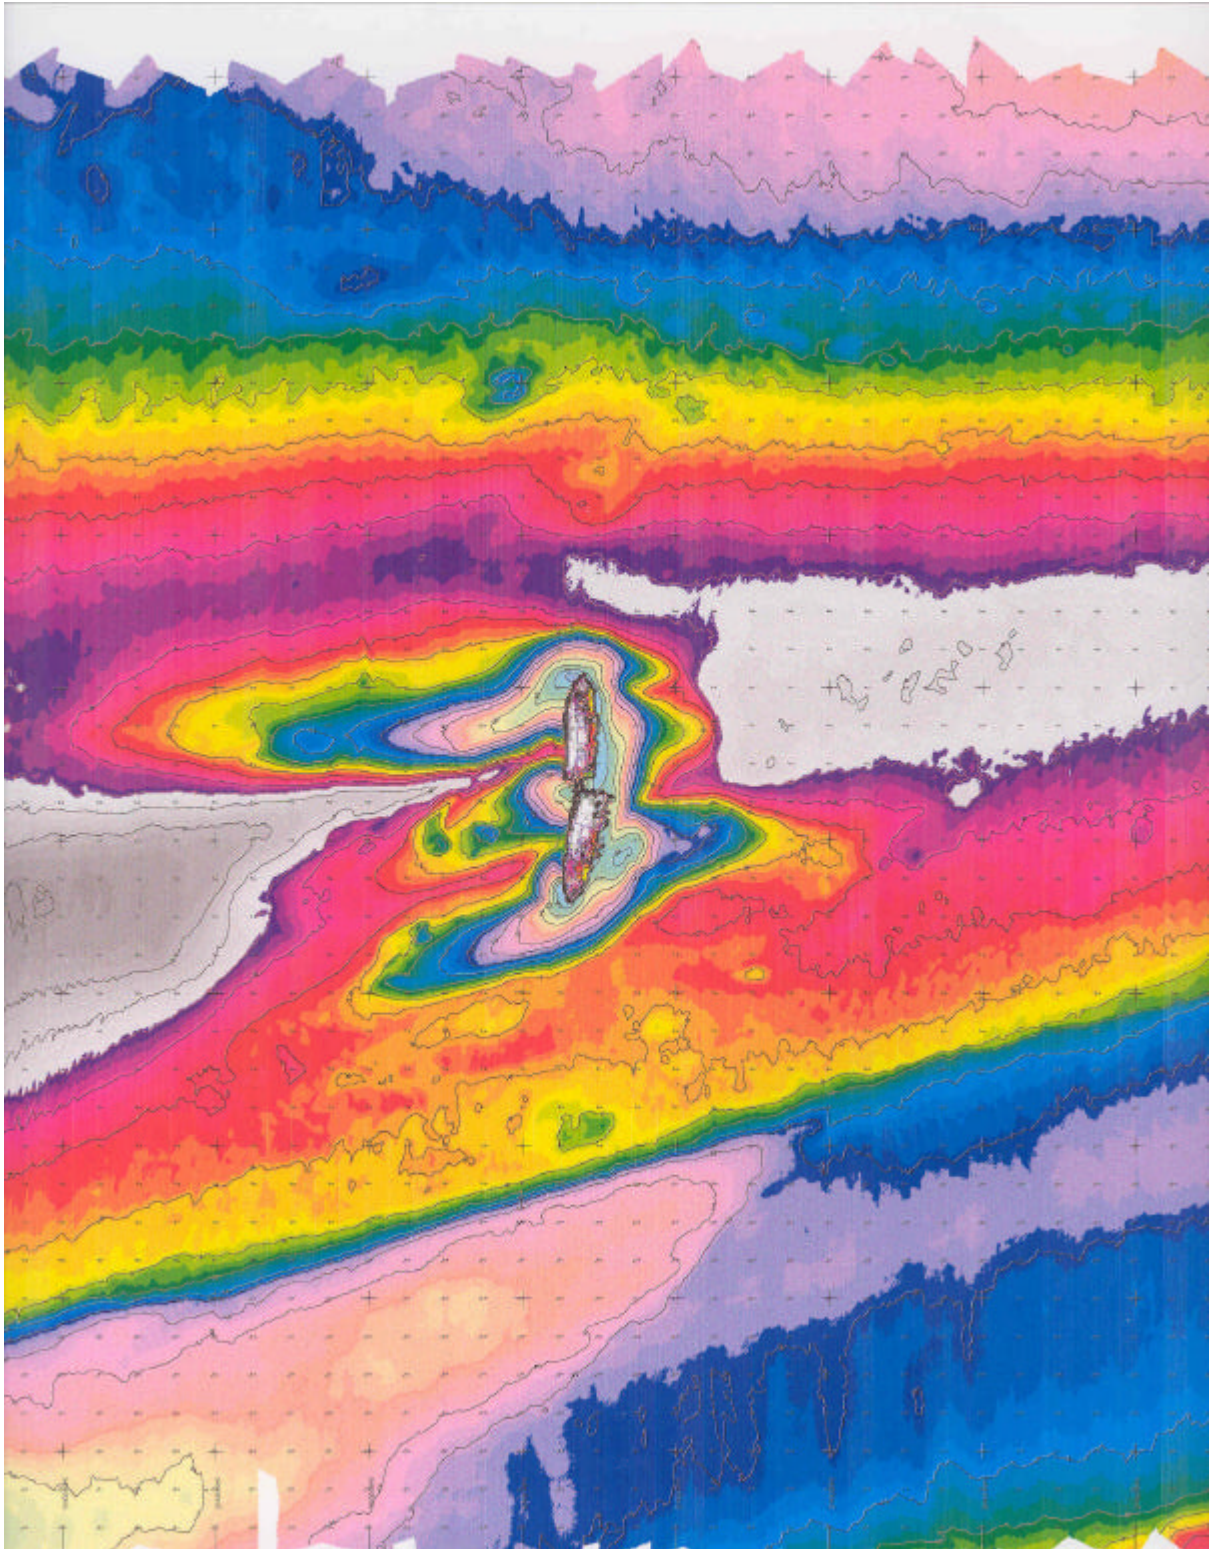
17. The following features within the survey area might be observed from the solid contour plot at Appendix 5:
  - **The Wreck Site**  
The wreck site occupies the central part of the survey area. It is the area enclosed by the 9-metre contour and may be considered to be the area of seabed topography most influenced by the presence of the wreck.

- **The Medway Dredged Channel**  
The Medway dredged channel occupies the southern part of the survey area, which is orientated in the region of 072°/252° and is bounded by the southernmost 9-metre contour in the survey area.

- **The Sheerness Middle Sand**  
The Sheerness Middle Sand occupies the central part of the survey area. This sand bank is most extensive in the western part of the survey area. It is broken by the wreck site and continues to the east of the wreck site. The 6-metre contour of this feature is continuous to the north, and to the south this feature is continuous along the 8-metre contour.
